HO-944
"Oakland Farm"
1825 McKendree Road
Cooksville vicinity
Howard County, Maryland
Private
c. 1899

Maryland Inventory of Historic Properties Form

Inventory No. HO-944

historic "Oakland Farm"
other

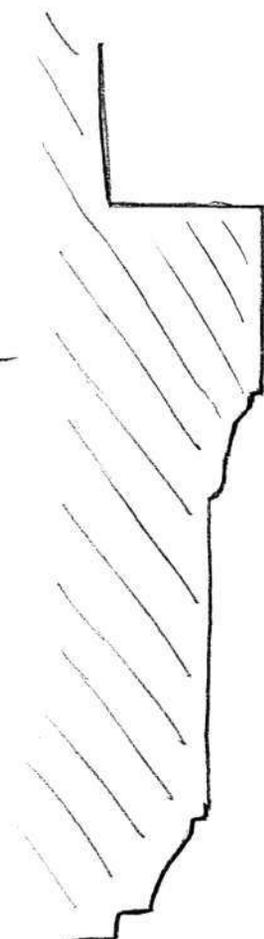
E11
SE Rm
Architrave

The southeast room in the ell has new flooring, plain baseboard, and architrave with a broken field and a small ogee at the break, plus a small ogee on the inner edge. The door on the east elevation has four lights over three lying panels. This room is an old kitchen with wood cabinets that probably date to the 1950's. There is drywall on the ceiling over circular-sawn lath that runs north-

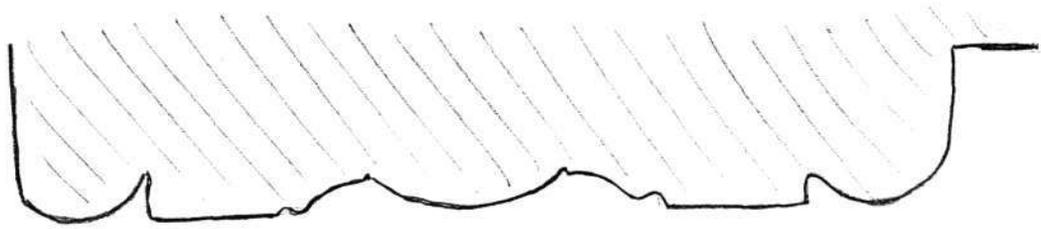
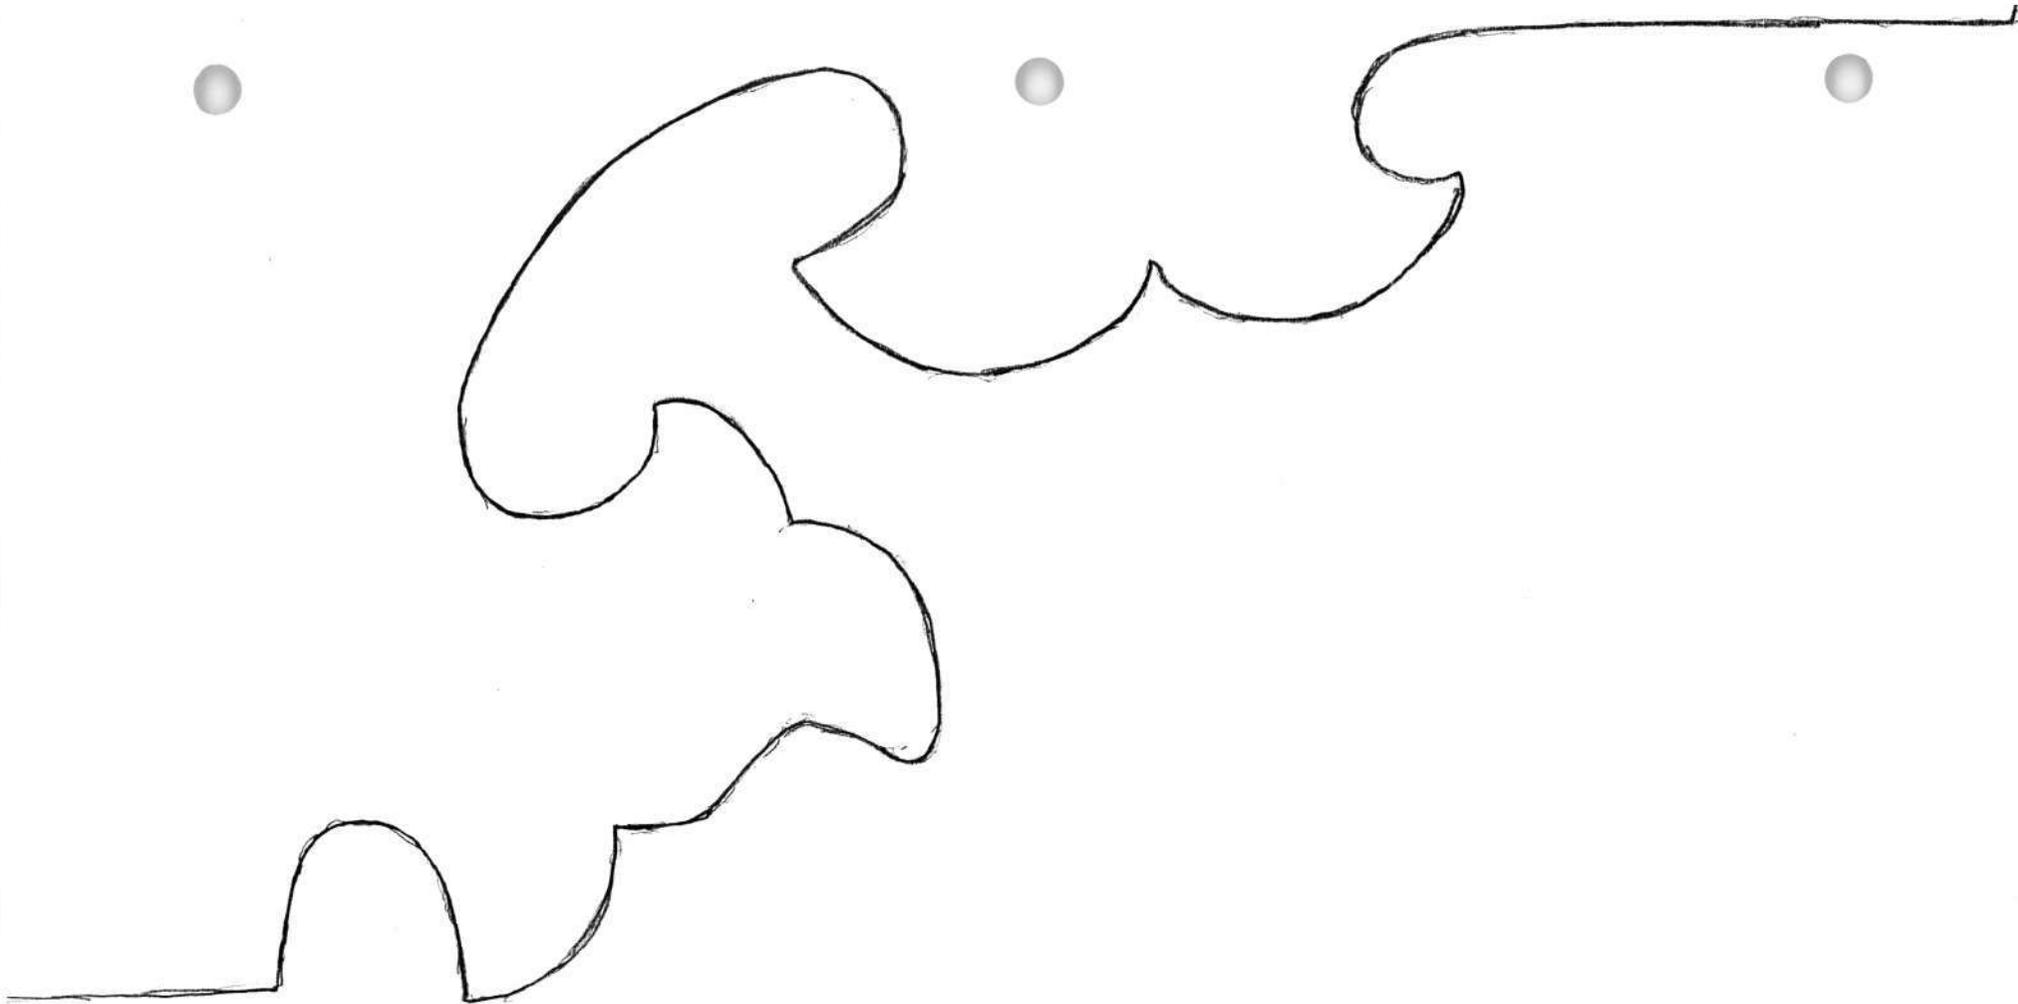
Passage Architrave

The house has a center-passage, single-pile plan with an ell that contains a cross passage to the west and two rooms to the east. The center passage has carpeting, baseboard with a quirked ogee and bevel, and symmetrical architrave that is pulvinated in the center, with a small cavetto to each side and a bead on each edge. There are also bull's eye corner blocks. The front door has four panels with sunken fields and ogee panel moulds. There is a mortise lock with porcelain knobs and butt hinges with three knuckles and ball finials. The side lights have been altered. There is a single panel below each that has a sunken field and a quirked ogee and bevel panel mould. The interior doors are four panels that match the front door, with plain cast-iron rim locks that have porcelain knobs and foliate cast-iron butt hinges with three knuckles and a mixture of ball finials and acorn finials. The doors are not mortised and tenoned and pinned. There is a straight-run stair on the north wall with an open stringer and sawn brackets. It has a turned oak newel post that has two pairs of beads around the center and a large acorn finial on top. There are turned oak balusters that have four beads around the center, and they are tapered. The oak hand rail is moulded. There is a small powder room at the east end of the passage that has typical architrave and a new door. The powder room has new tile and new fixtures, and there is typical architrave on the inside of the door. The stair newel has a drop pendant that comes down through the ceiling of the powder room. At the east end of the stairs, north of the doorway to the powder room, is a door to the cellar steps. It has typical architrave, but has a four-panel door with flush fields that have ovolo panel moulds, and this door is mortised and tenoned and pinned. It has a typical rim lock and butt hinges with two knuckles, but is much older than the other doors in the house. The interior side of this door is grained.

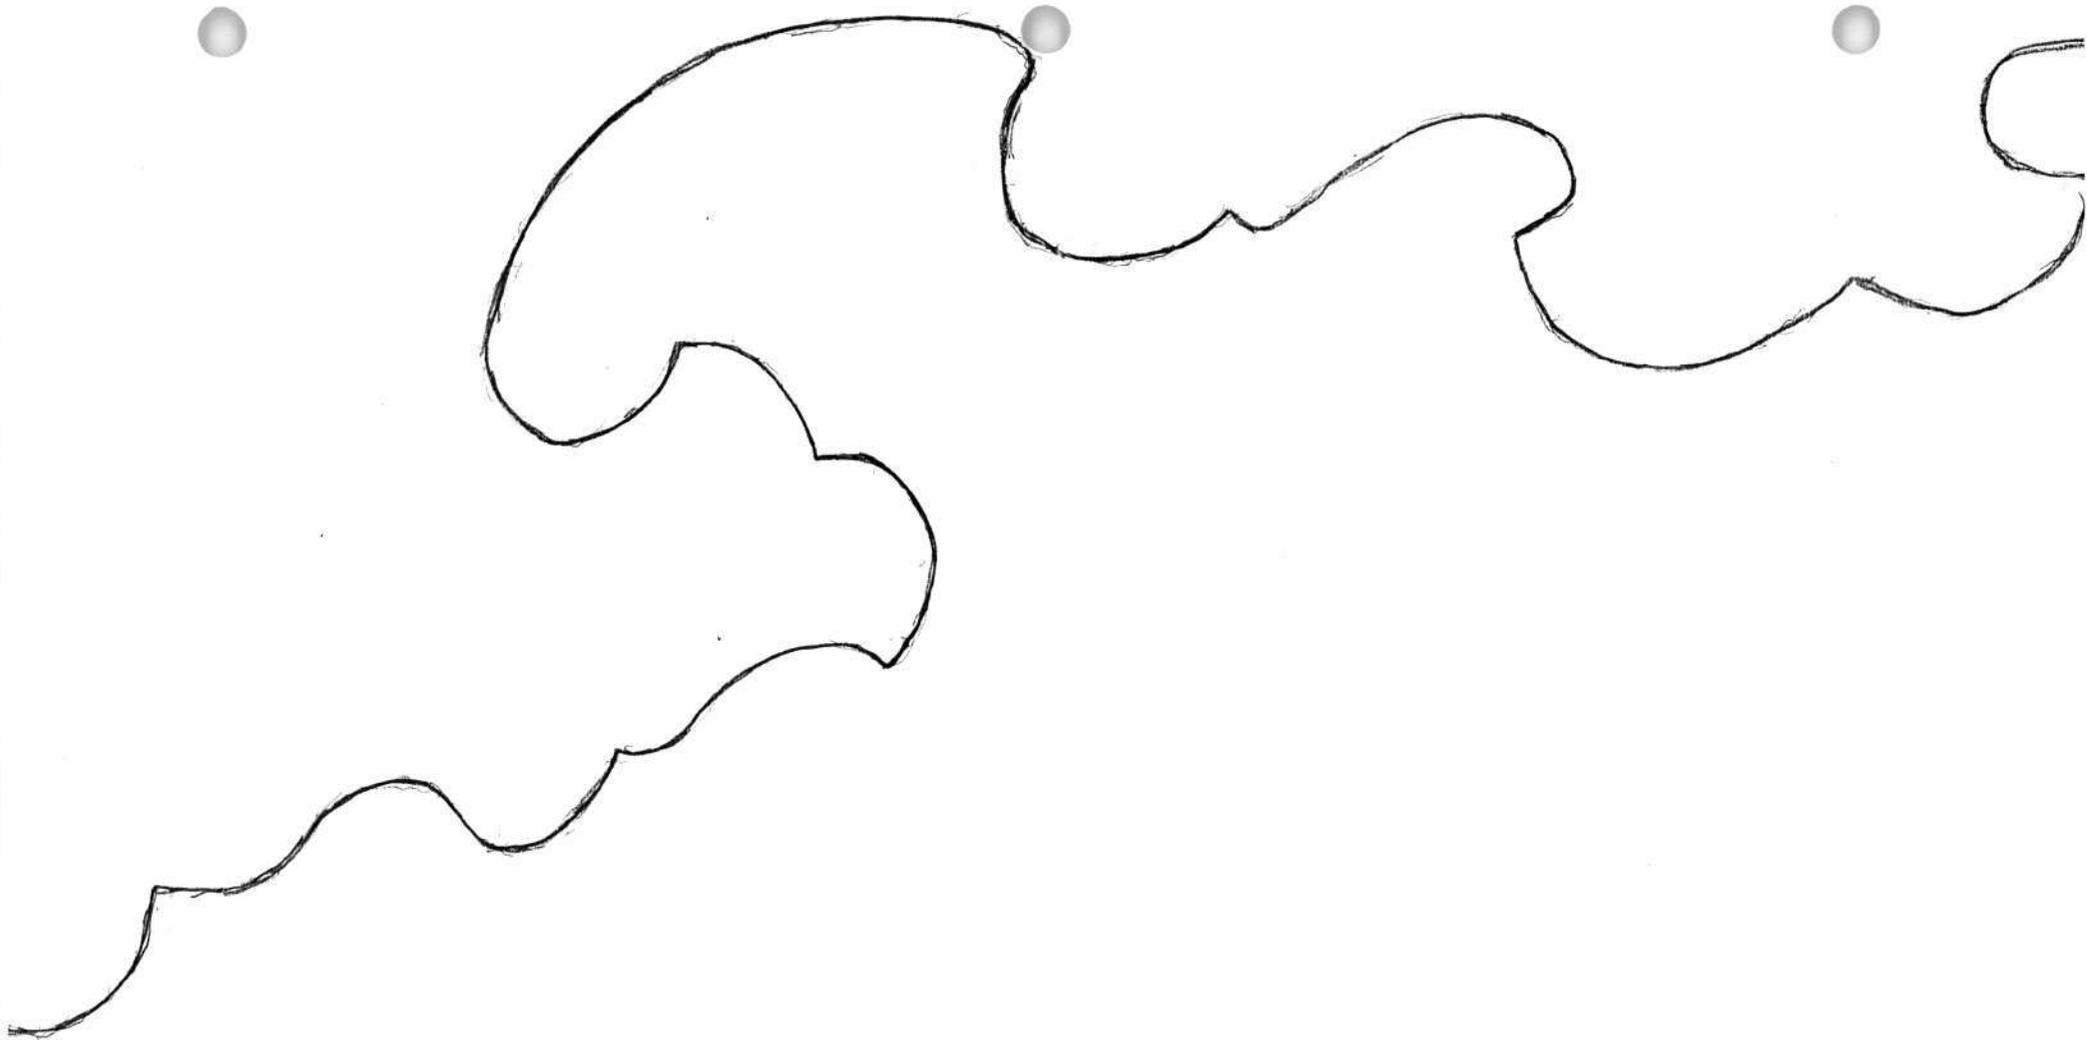
1825 McKendree Road
Stair Bracket

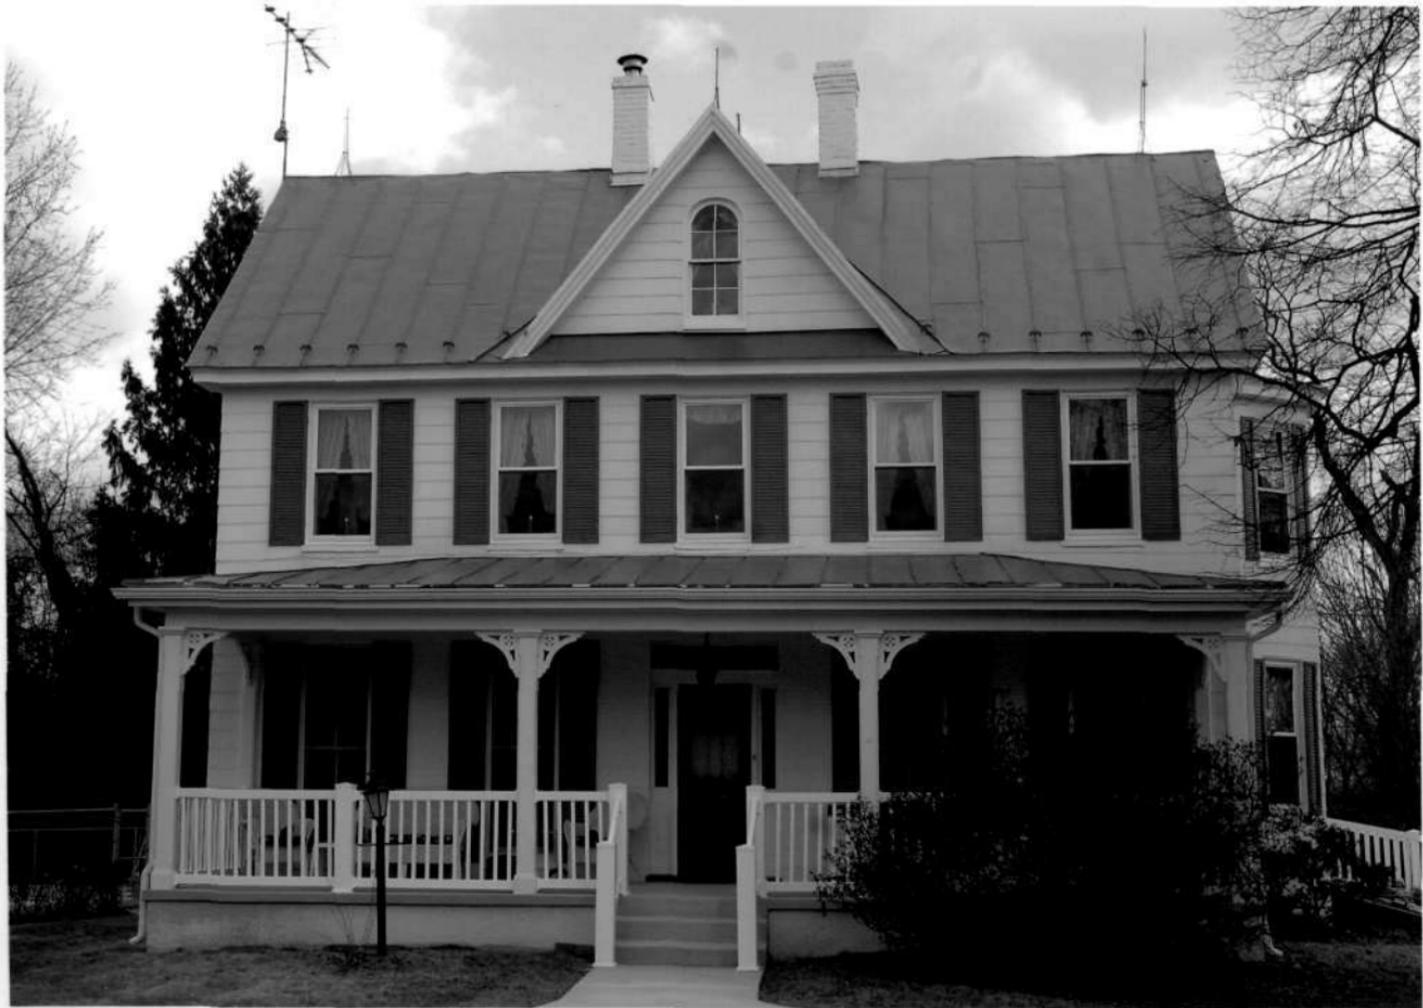
1/17

House, West Elevation

The house is a two-and-one-half story, five-bay by one-bay frame structure with a two-story, three-bay by three-bay ell the rear. The main block has a rubble stone foundation, frame walls with asbestos shingle siding, and a gable roof with standing-seam metal, a north-south ridge, and a cross gable on the west elevation. The ell is three-to-one common-bond brick on the first story and a frame second story with asbestos shingles. There is a gable roof with standing seam metal and an east-west ridge. On the west elevation, the first story has a center door with four panels that have sunken fields and bolection panel moulds. The top panels also have pediments at the top and sills at the bottom. The bottom panels have bull’s eye corner blocks. The posts that flank the door and separate the side lights are chamfered. The side lights originally had three lights but have been converted to single lights, the transom bar has a scalloped applied decoration with drill holes and what appears to be a geometrically stylized egg and dart moulding. The transom has three lights with new glass. There are two new two-over-two sash on either side of the doorway, with fake shutters. There is a five-bay, one-story porch on the west with a concrete deck and new plastic railings. There are chamfered boxed posts with sawn brackets that have a rosette in the center, and these appear to be reused when the porch was significantly reconstructed. There is bead-board soffit on the porch and a half-hip roof with standing-seam metal. The second story has five new one-over-one sash and the cross gable has a semi-circular-arched four-over-four sash. There is a wood cornice with returns. Two interior brick chimneys flank the cross gable on the ridge.

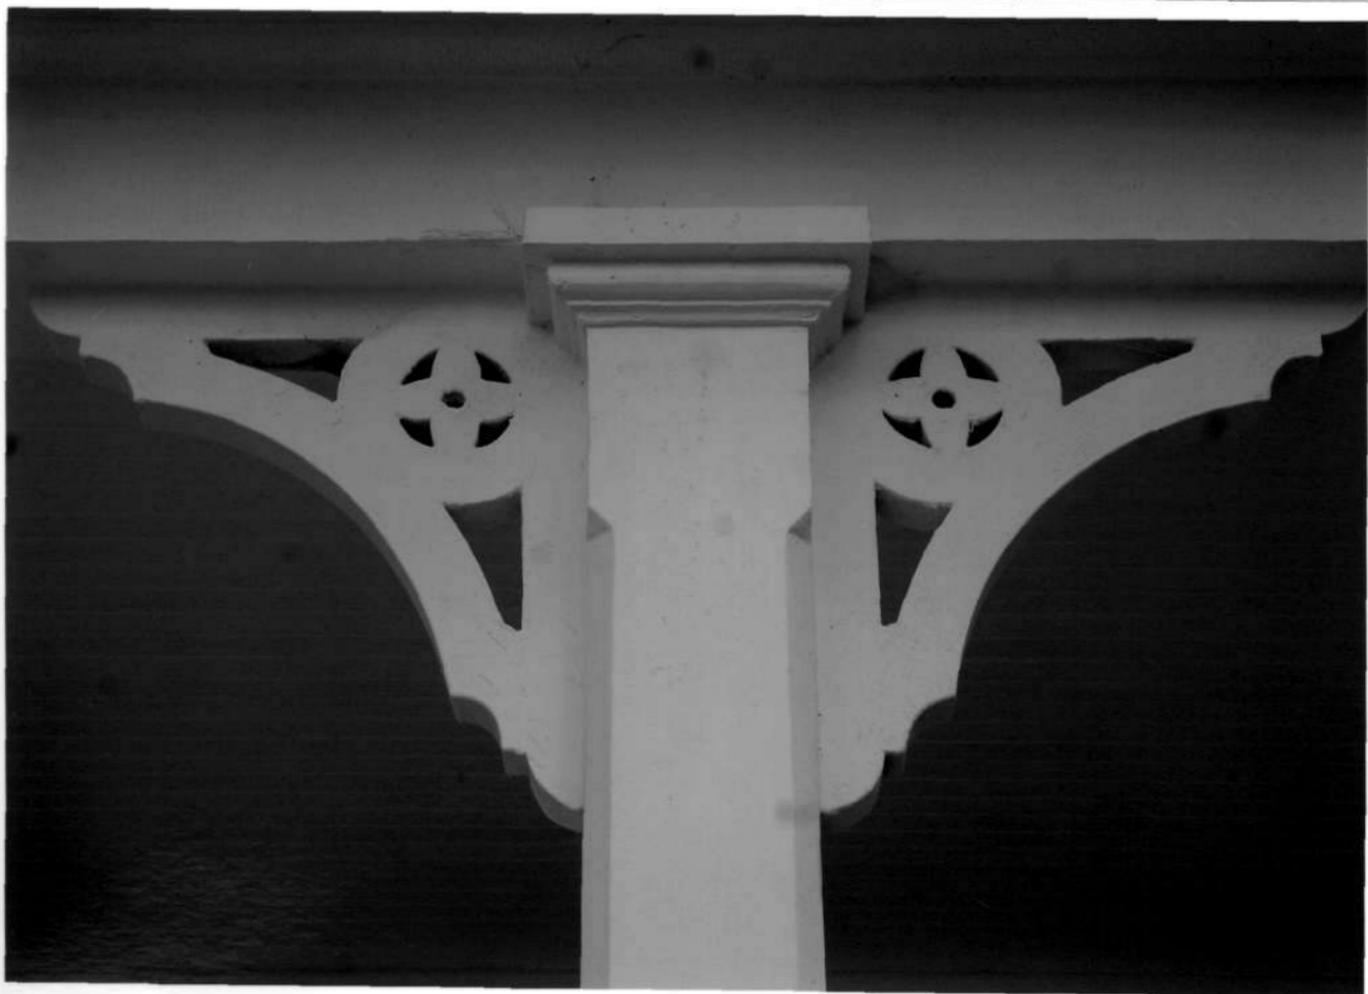
2/17

House, west Elevation, Porch Bracket

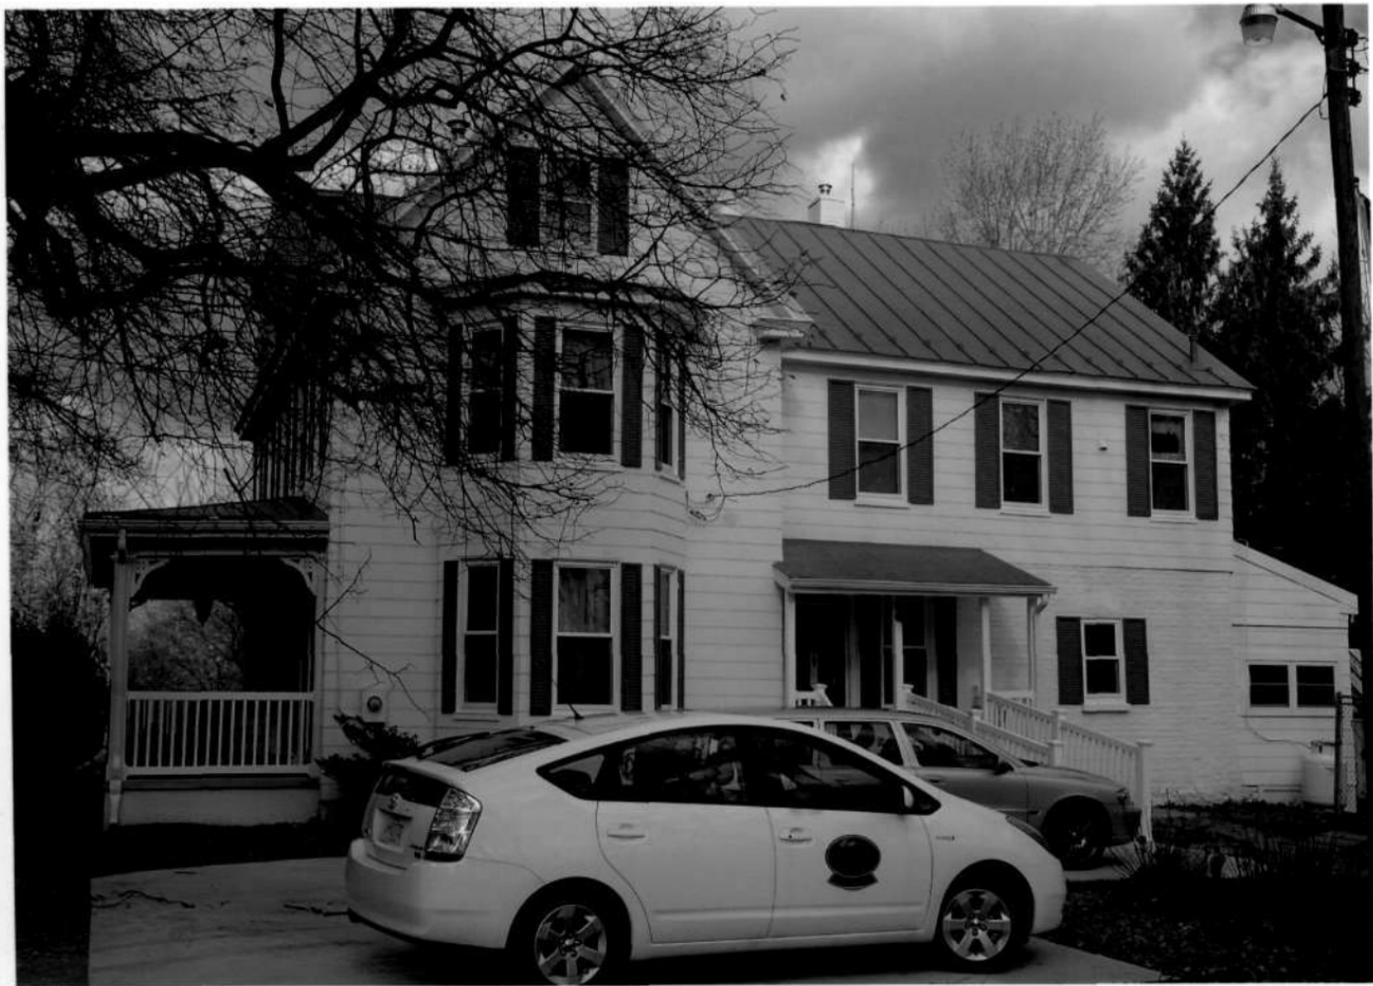
3/17

House, South Elevation

The south elevation of the main block has a cellar bulkhead entrance in front of a three-sided bay window. The bay window is two stories tall with a low roof, and has three one-over-one sash on both the first and second stories. The gable end has a two-over two sash. The ell is recessed from the plane of the main block and the brick is painted, with some shallow struck joints. The first story has a door in the west bay with two lights over two panels, and has a wood lintel. The brickwork here appears to be cut through and patched. Set west of center is a new one-over-one sash with a wood sill and lintel and there is a new porch over these two west bays. The east bay of the ell has a small one-over-one sash in a segmentally-arched opening, with a wood sill. The second story has three one-over-one sash. There is a wood box cornice with returns and an interior brick chimney just west of center.

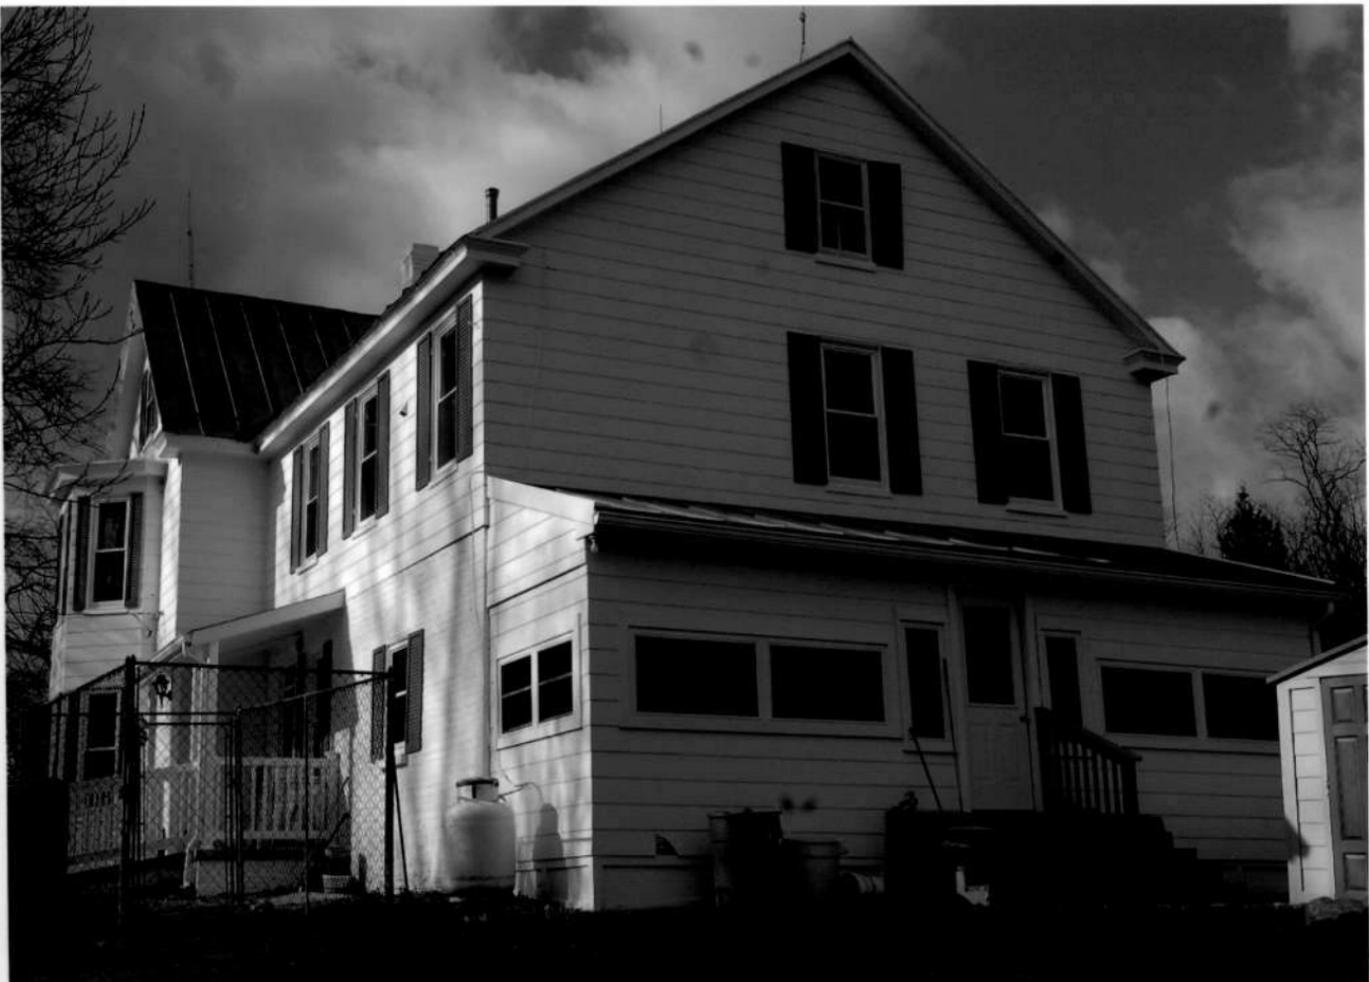
4/17

House, South and East Elevations

The east elevation has an enclosed porch on the first story with all new openings. The east wall of the ell has doors in the end bays that have four lights over three lying panels, and there is a pair of four-light casements in the center hung on butt hinges with ball finials. New bead board covers the brick wall of the ell. The second story has a one-over-one sash in the center and the north bays and the gable end has a one-over-one sash. The north elevation of the ell has a one-over-one sash in the east bay that has a concrete sill, a wood lintel, and rebuilt brick above the lintel. There is a door set west of center that matches the west elevation, with a one-over-one sash next to it. Both of these openings have wood sills and lintels. There is a new porch covering these two openings. The brick around the doorway appears to be rebuilt. The second story has two one-over-one sash, with nothing in the center bay. The north elevation of the main block has two two-light sash in the foundation. The first story has a one-over-one sash in the center and the second story has two one-over-one sash. The gable end has a two-over-two sash.

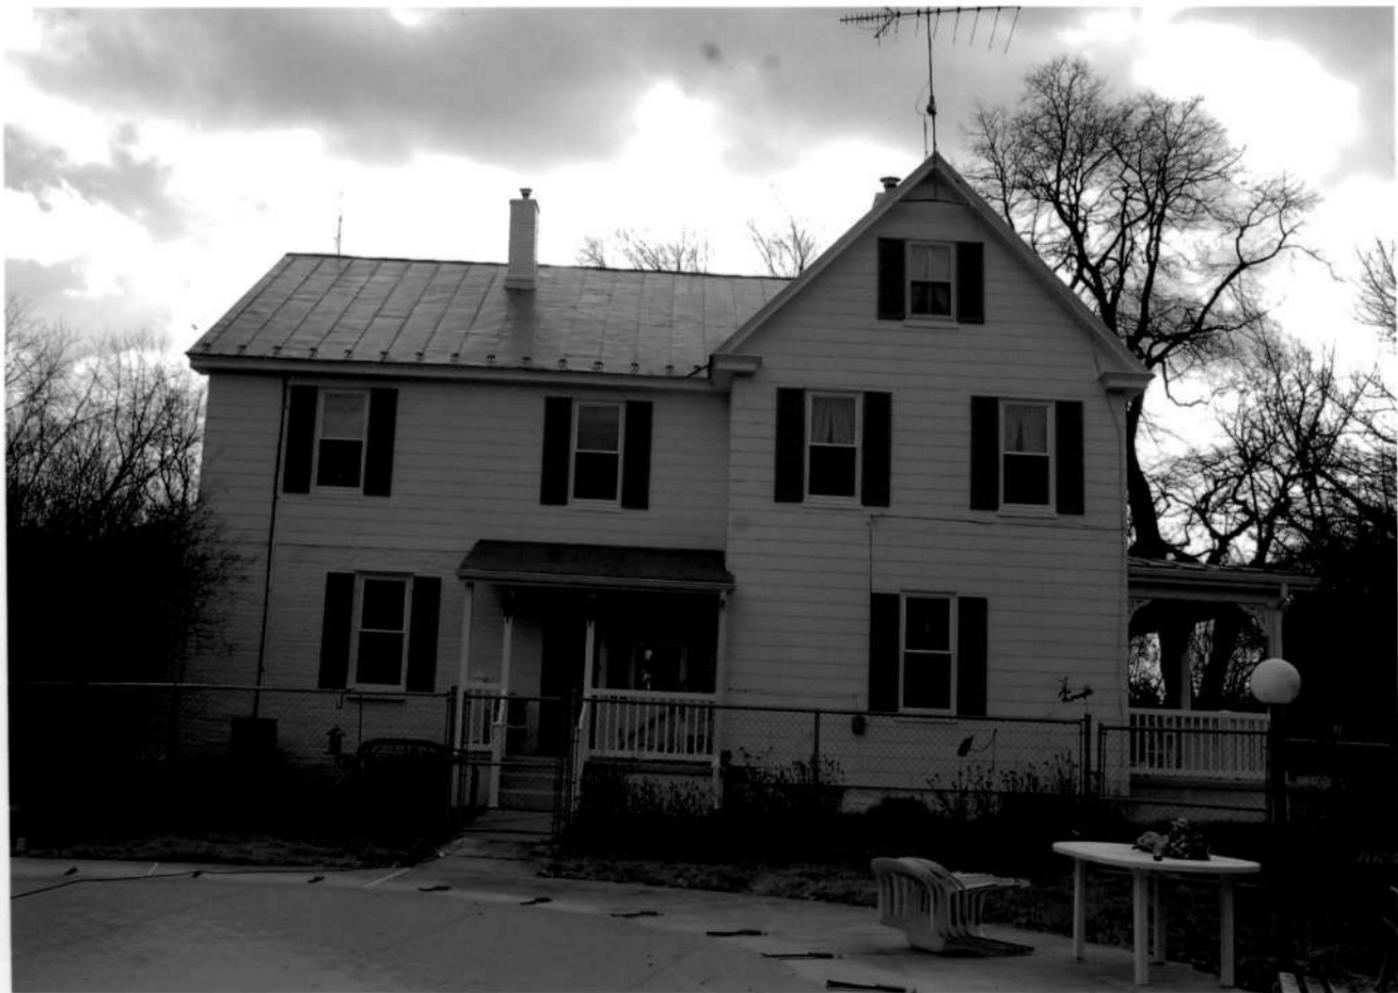
5/17

House, North Elevation

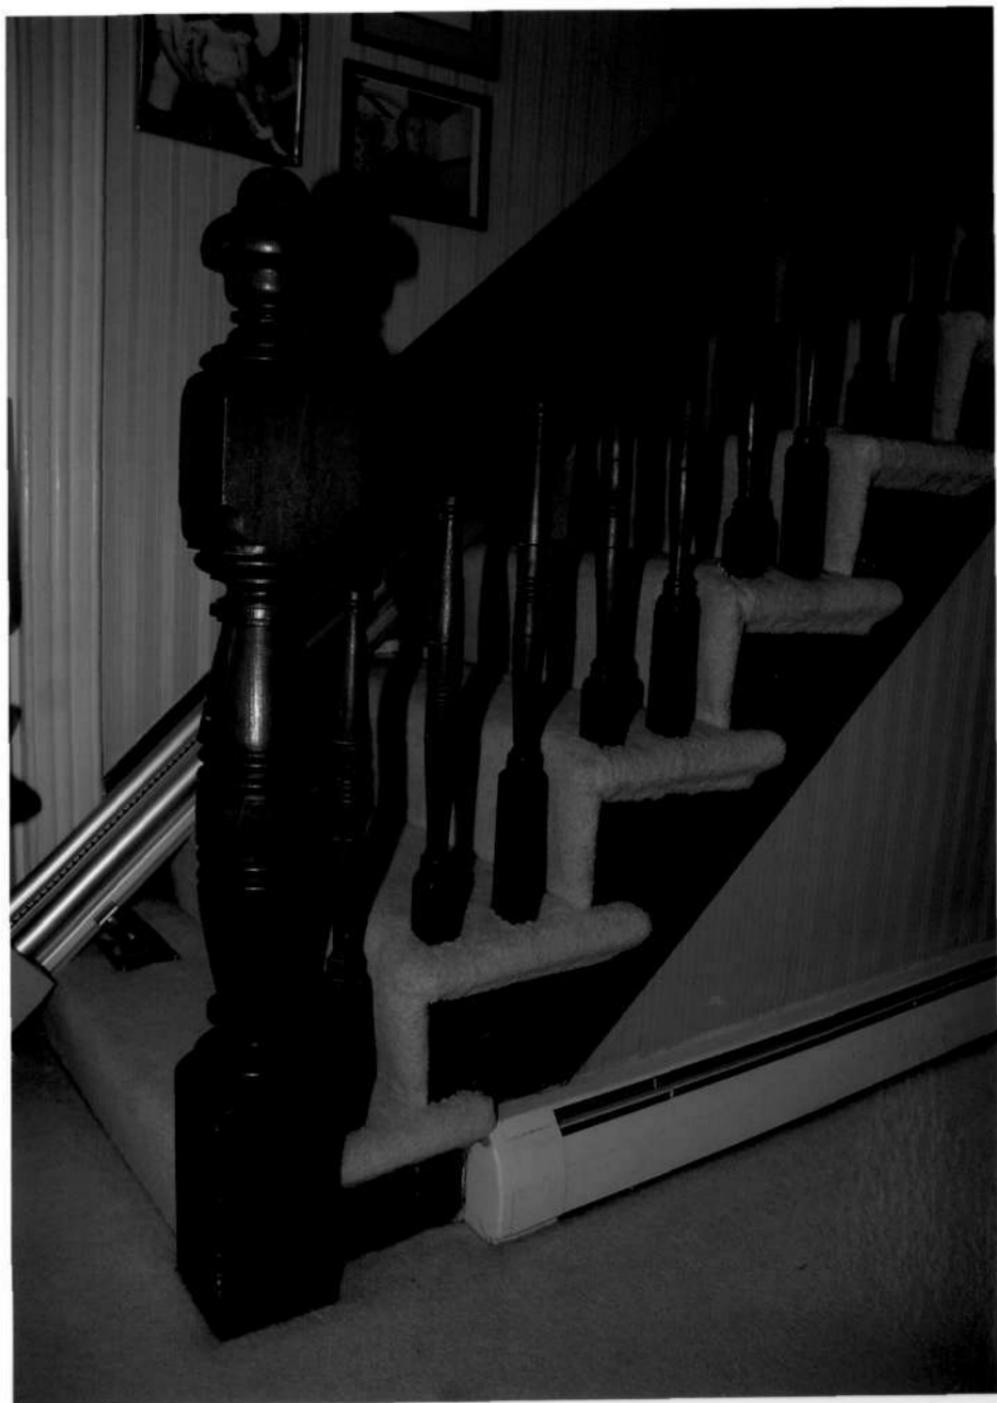
6/17

House, Interior Stairway

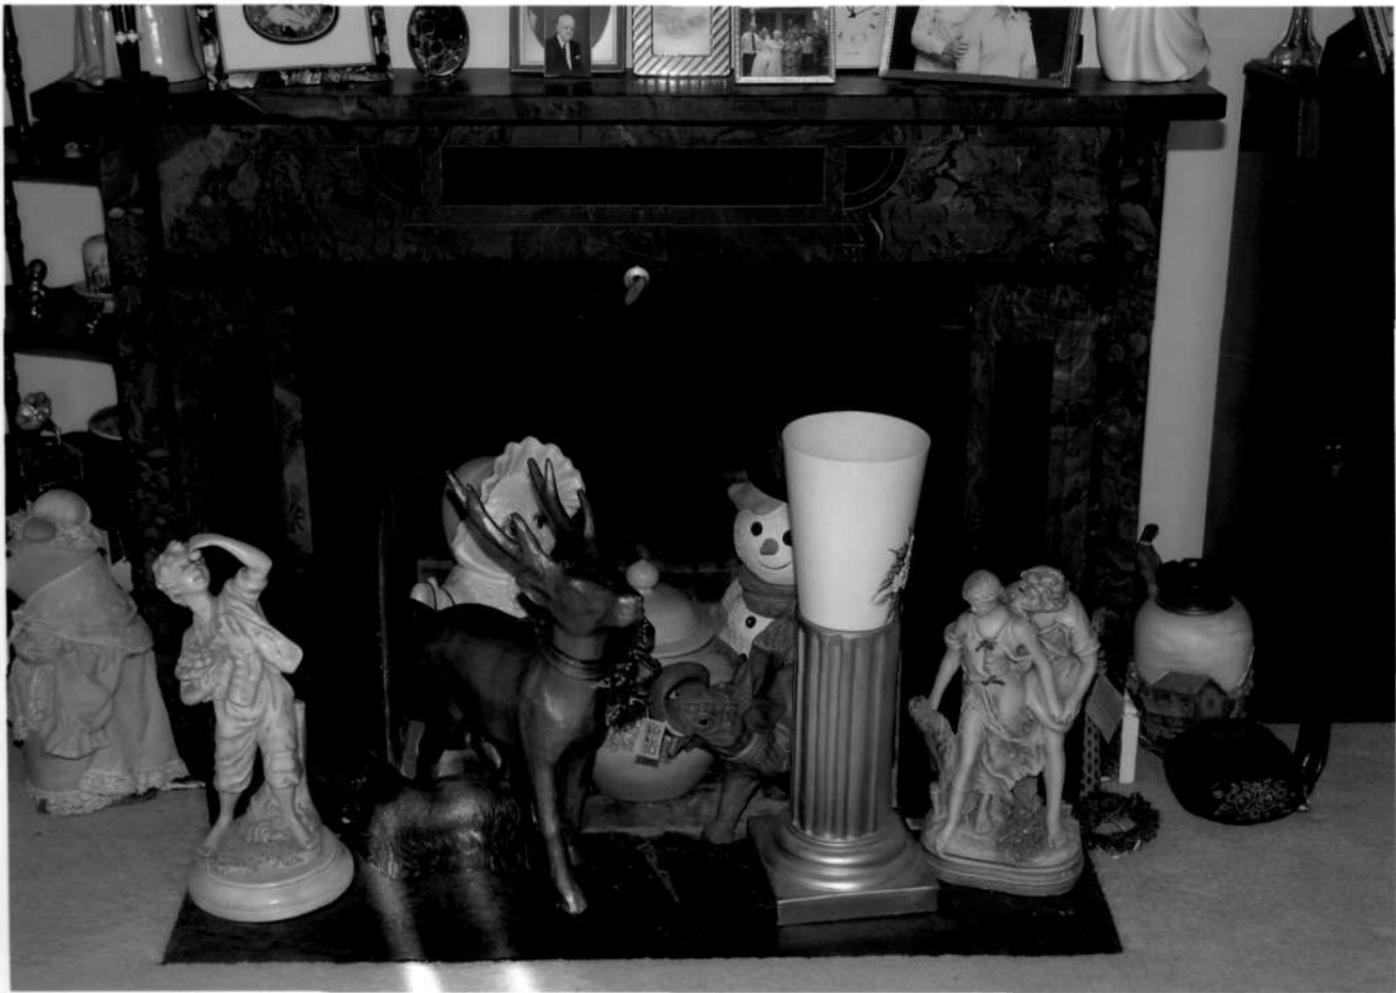
7/17

House Interior, South Room Mantel

The south room has carpeting and typical baseboard and architrave. The west windows extend down to the baseboard. All of the sash on the first and second stories are new. There is a fireplace on the north elevation that has a slate hearth and firebrick on the floor of the firebox. It has straight brick jambs. There is a marbleized slate mantel with a semi-circular-arched opening and pilasters with incised geometrical detail. Similar decoration is on the otherwise plain frieze, and there is no bed mould and a plain mantel shelf. The south elevation has a bay window. The east wall has a pair of French doors with modern trim. This wall is very thick and is hollow on the west side, while it is plaster on masonry on the east side.

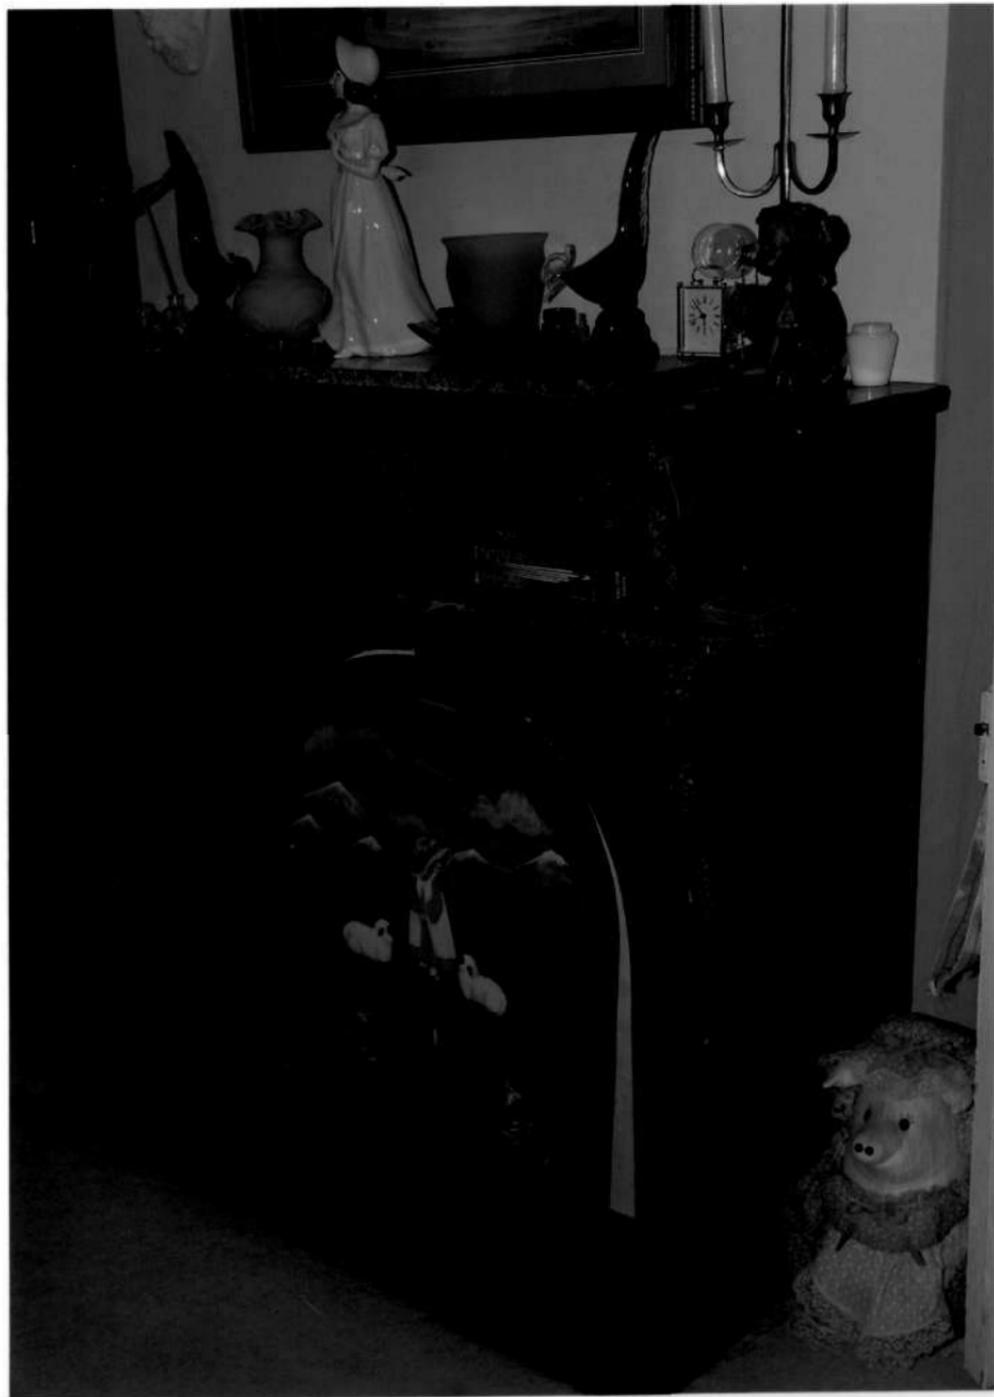
8/17

House Interior, north room Mantel

The north room has carpeting and typical baseboard and architrave. The west windows also extend down to the baseboard. On the south elevation is a fireplace that is closed off and appears it was never a working fireplace, but was probably always a flue for a furnace. There is a slate hearth and a marbleized slate mantel with scroll brackets on the face of chamfered pilaster strips. These brackets support a small shelf at the bottom of the frieze, and there are short brackets below the top mantel shelf. The mantel has a round-arched opening with a painted metal cover. There is incised geometric design on the pilasters and the frieze. The east wall has a pair of French doors and modern trim, and this leads to the cross passage in the ell.

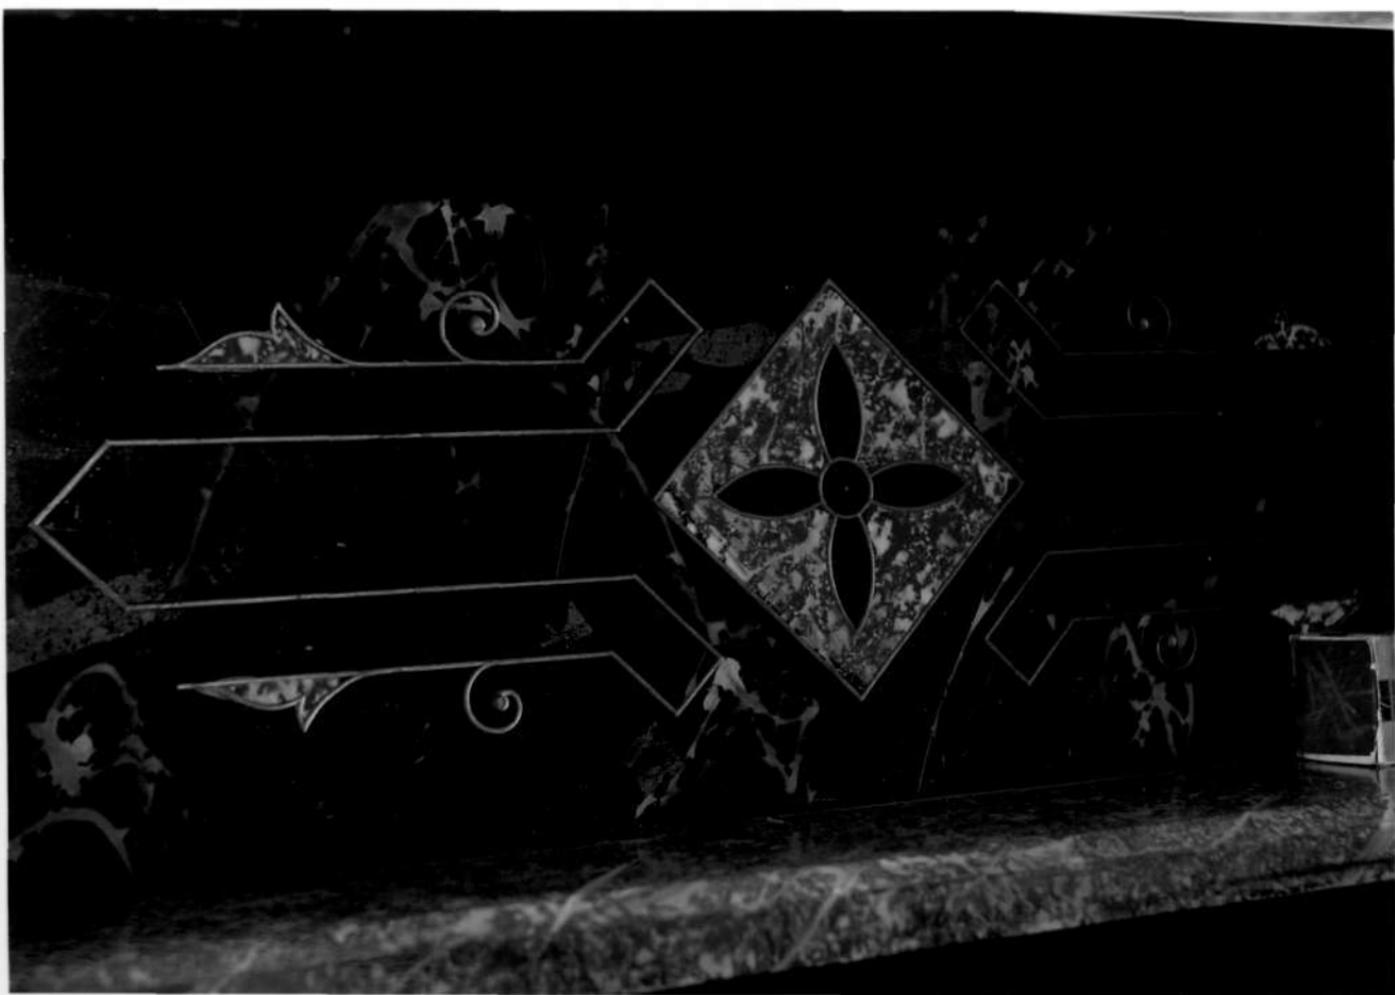
9/17

House Interior, North room mantel. Detail

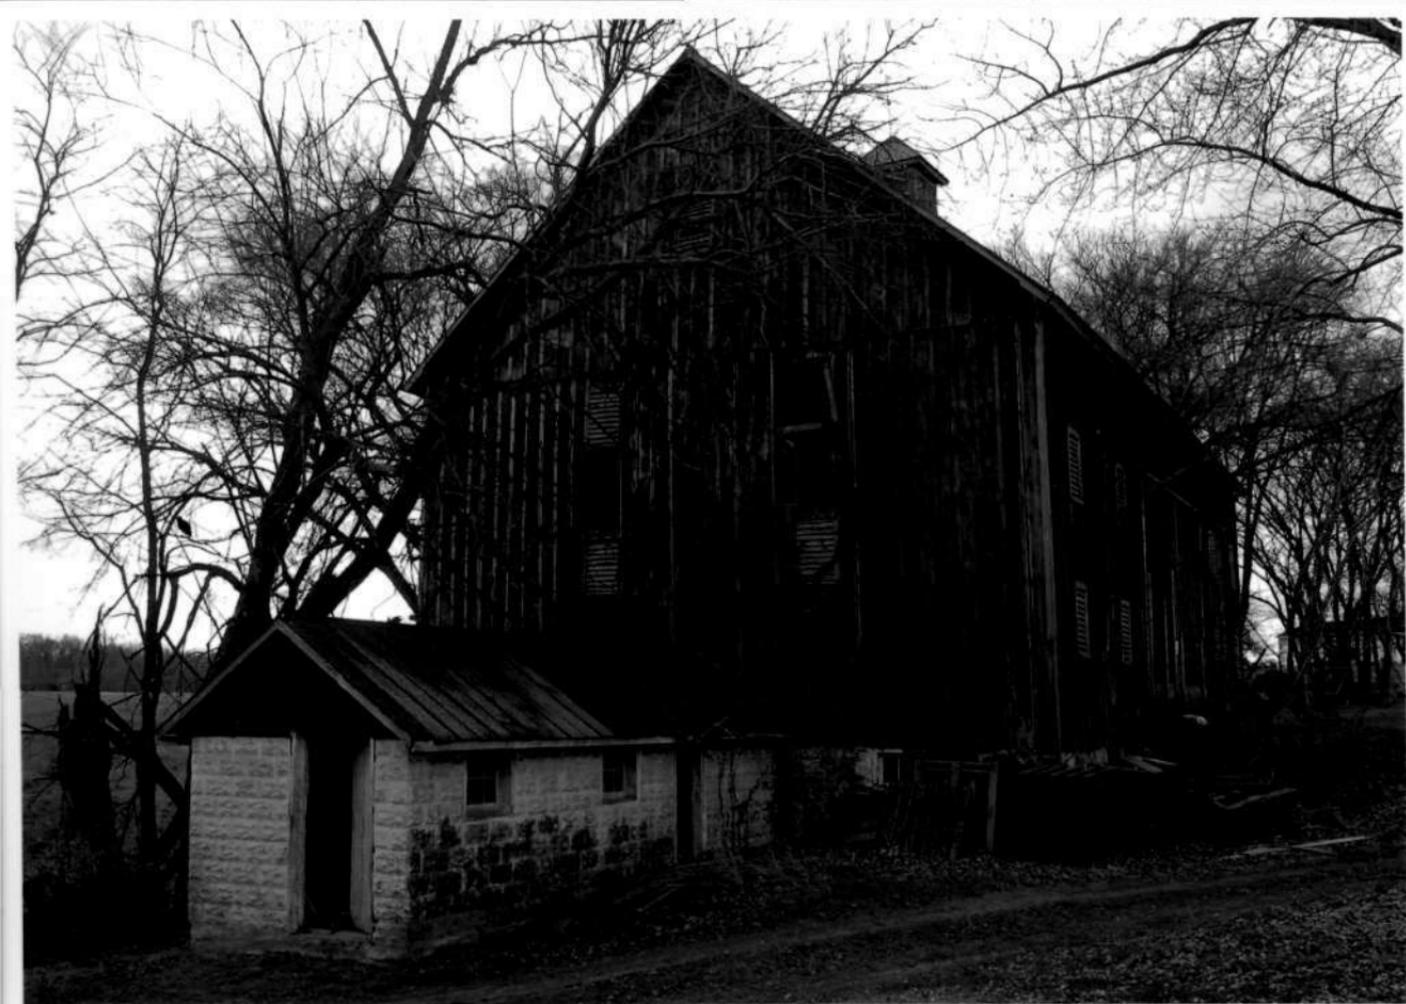
12/17

Barn and Dairy, east and north elevations

The dairy is a one-story, three-bay by one-bay rock-faced concrete block structure with a gable roof that has an east-west ridge and inverted-v-seam metal. The south elevation has an opening in the west bay, while the center and east bays each have a six-light sash. The east elevation has a bead-board door. The north elevation has a six-light sash in the east and center bays and a bead-board door in the west bay.

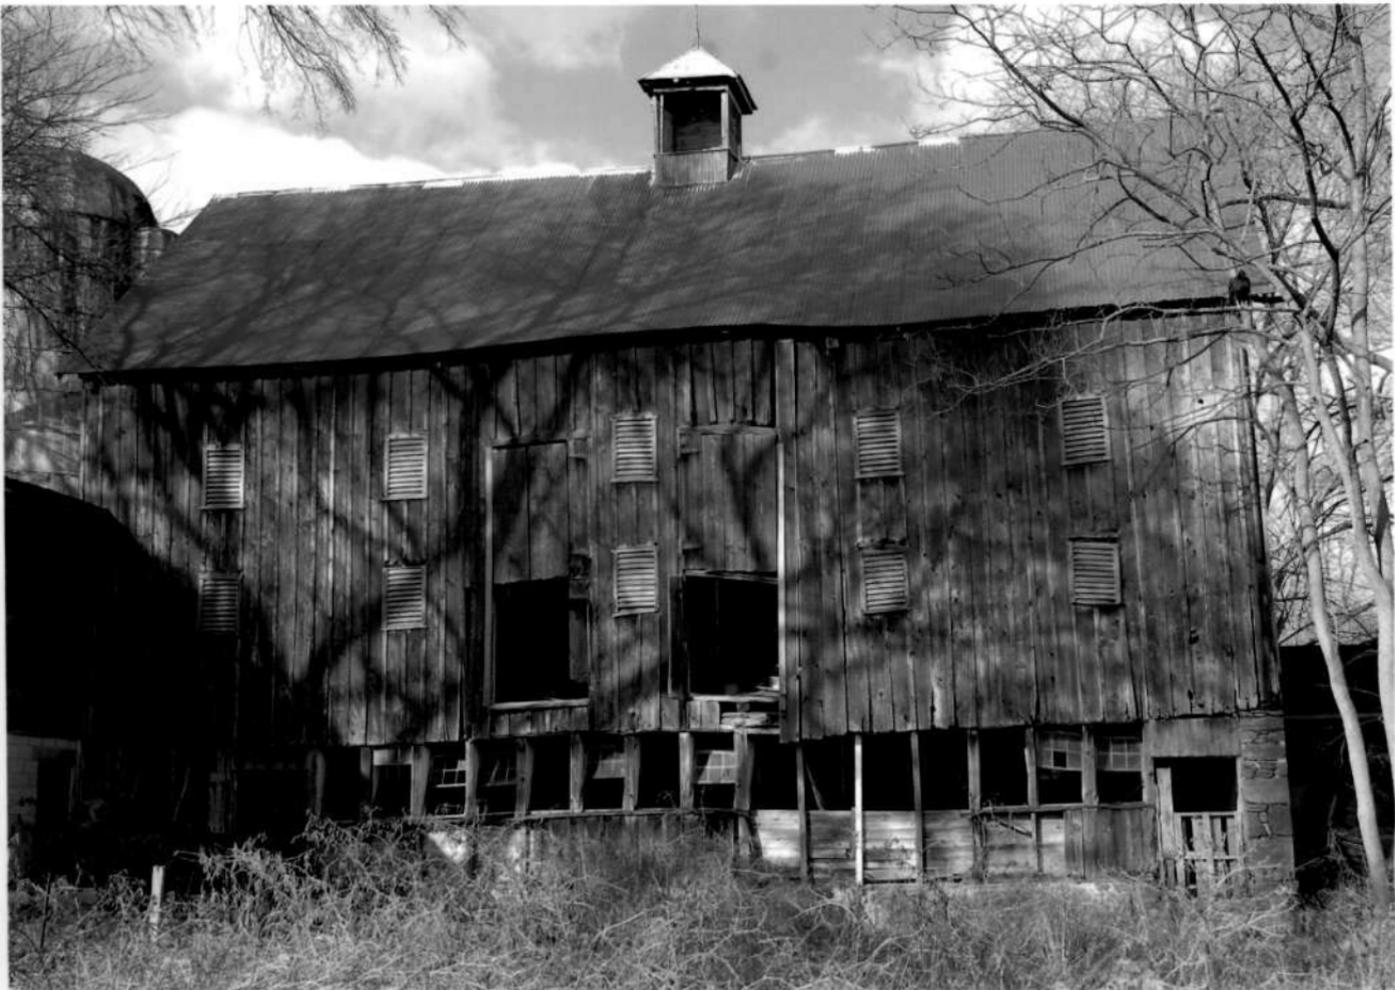
13/17

Barn, South Elevation

either side of the wagon doors are four vents, placed two above two. There is a name painted above the door, most of it hidden by a later name plate added over top. The visible letters are "OA ??? RM."
